## OBSERVATIONS RELATED TO THE DESIGN AND OPERATION OF AN ARTICULATED RUDDER

**Abstract:** Work shows a complex analysis of the effects of bearing mounting a naval articulated rudder

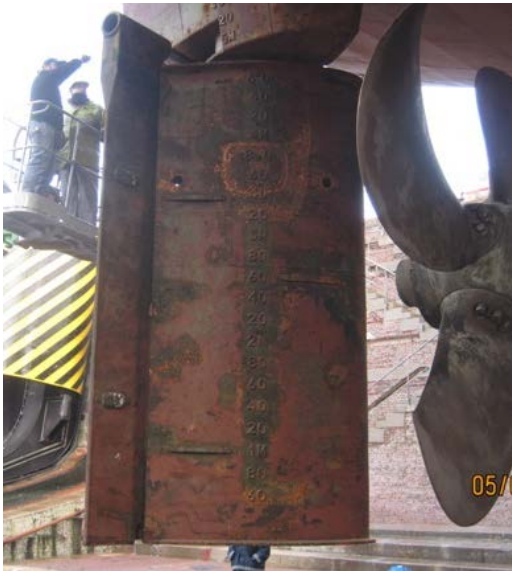
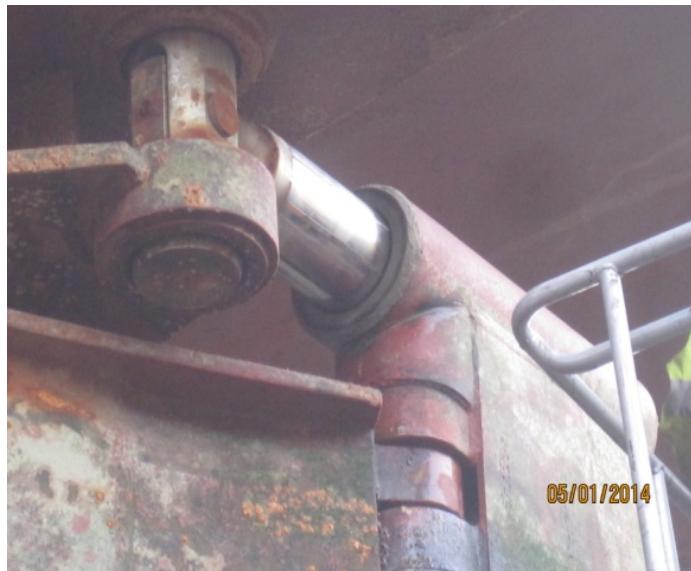
**Fig.2. Aspects during the inspection in order to achieve the evaluations of the rudder assembly at the docking ship.**

To compensate deformations of the steering mechanism under the action of water pressure the sliding mechanism is mounted with gap using the bush according to Fig.2 b.

a- maximum helm rotated

b - rudder in inclined state

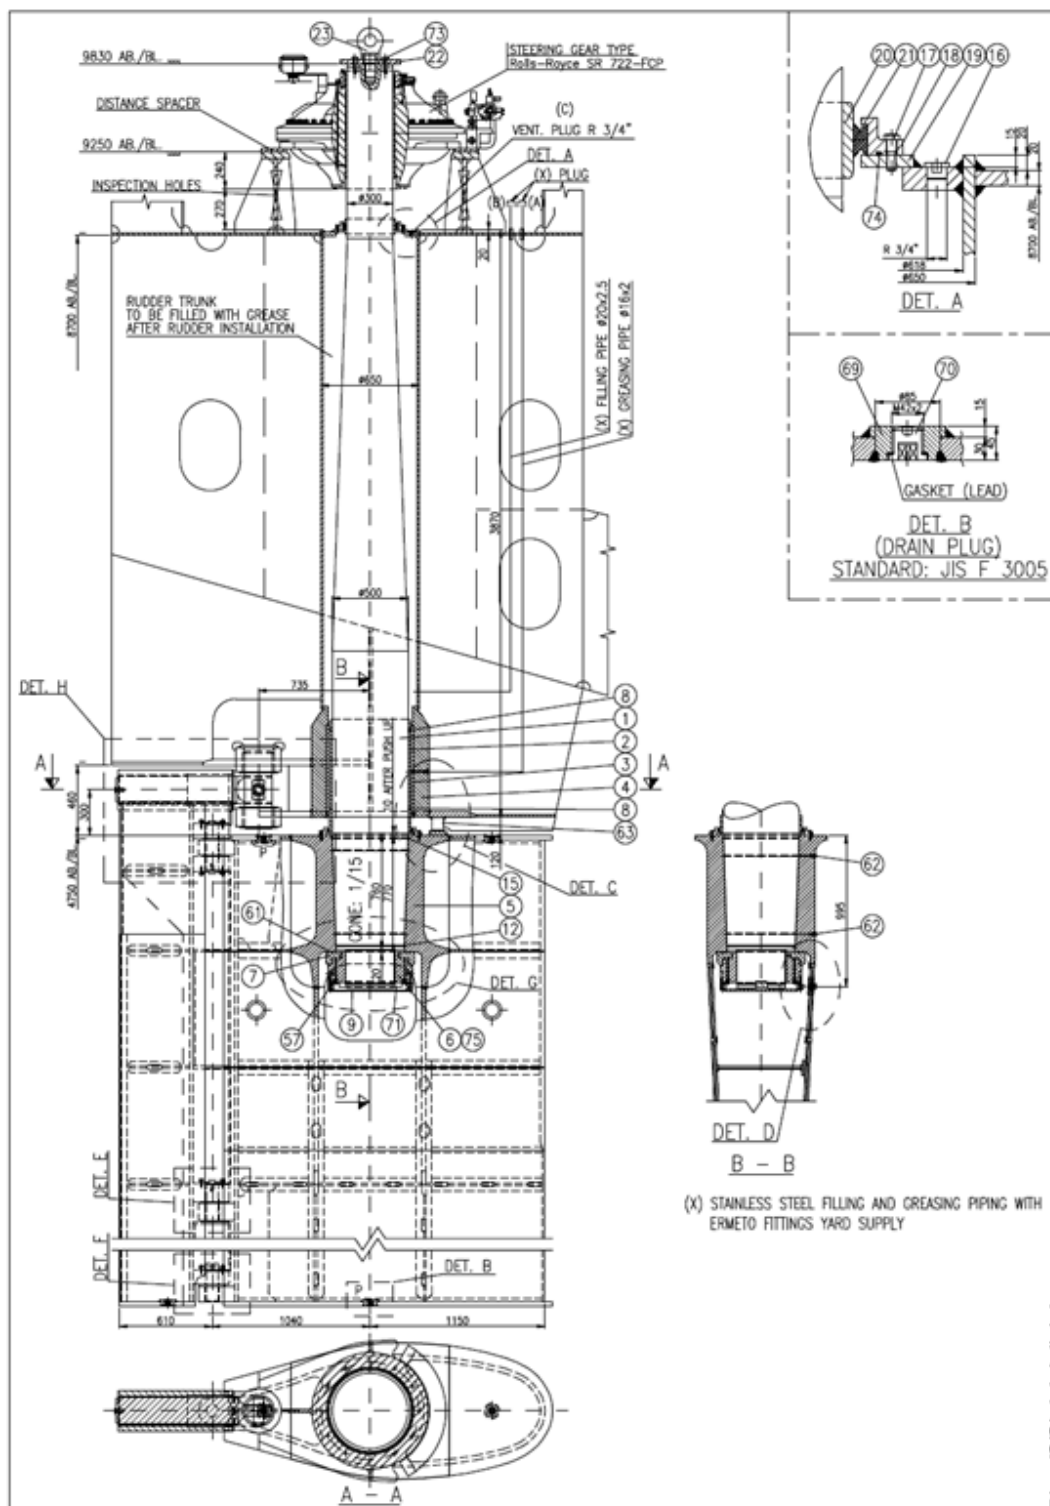
### Fig.3. The Rubber Design

In order to understand easily and better the phenomena that led to the need of the ascent on the dock and repairs, in Fig.3 is rented the assembly drawing of the rudder assembly. From fig. 3.can be seen the hydraulic gear type BOSCH. This is disposed axially within upper end of the rudder stock. The mechanism realizes the rudder with a couple of forces that is being developed by a circular piston with two rooms. Regarding of the insurance system steering shaft assembly, you can see that is a fixed three coaxial bearings. This involves precision design and assembly of achieving particularly large. Additional force of maneuver performed by the articulated steering, obtained due to an extra hydraulic resistance given by flaps, much higher

compared to simple ones. This additional strength requires additional load of the bearings system. Because the rudder is mounted in the console, lower bearing shaft has a maximum of radial load that must take. The lubrication is performed with fluid grease.

This lubricant fills the rudderstock housing volume. Column of lubricant achieves a relatively constant pressure on the lubricant film in this bearing .We can speak of a carrier film from the bearing, partially hydrodynamic and hydrostatic part. Additionally this lower bearing can be supplied with lubricant under pressure through a restrictor centrally placed in the rudder, halfway up the lower bearing.

Another interesting aspect can be seen in the way of wear, of the higher bearing for which the constructive solution is given in the detail A In the rudder drawing shown in fig. 3. As it results from this drawing, to compensate for misalignment for the three bearings, and of technological errors from the design and mounting, was chosen for anti-friction material bearing deformable, made of Teflon.

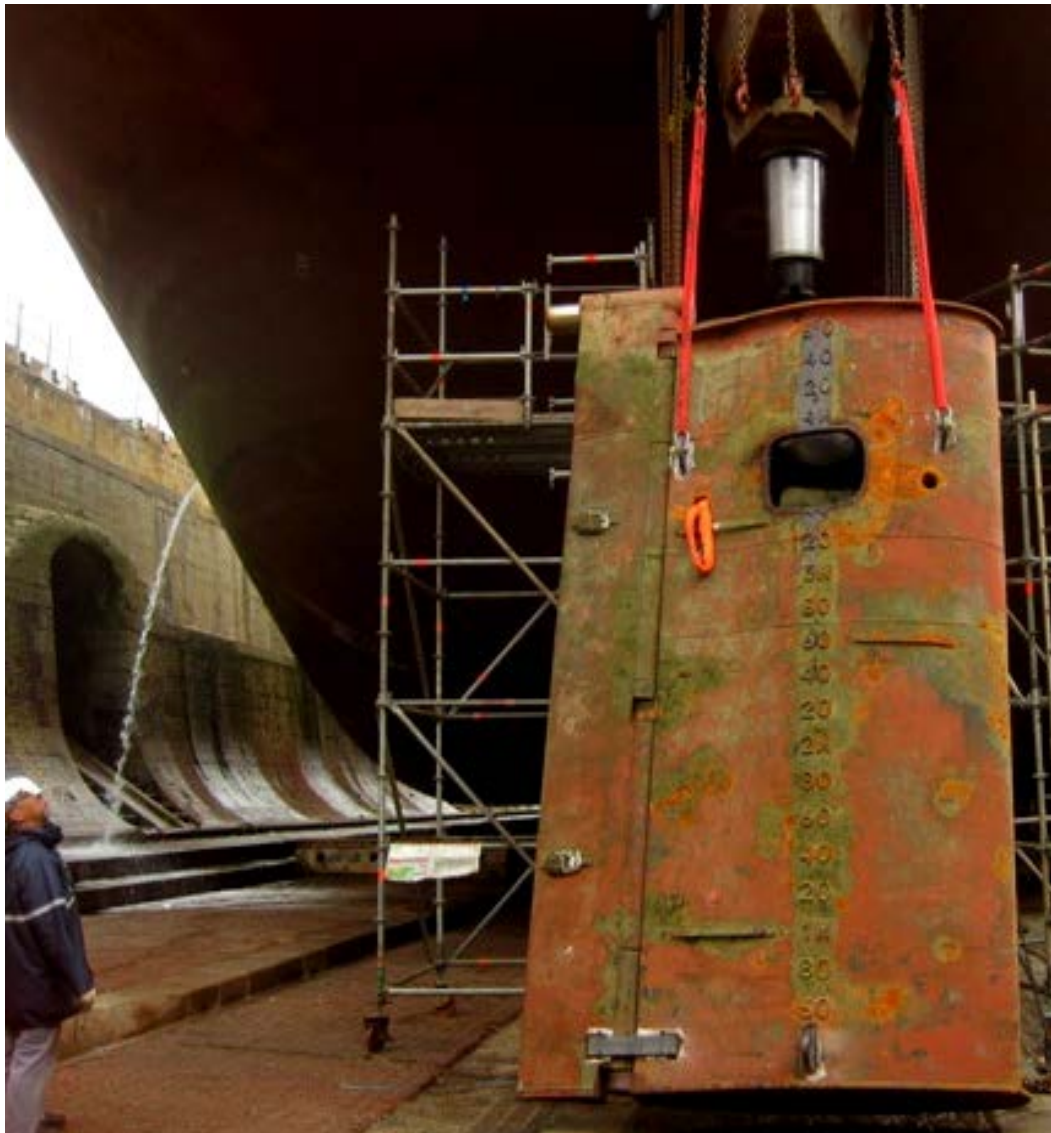
**Fig.4 Example of the cone assembly and maintenance operations**

For the fulfillment of the mounting conditions, to the fitting rudder after repairing the bearings system, in fig. 4 is presented the fixing solution of the rudder flap by welding on each side of two

pieces of sheet metal. After reassembling of the rudder the two paths will be cut and removed. Also we have noticed temporary auxiliary constructions necessary handling rudder blade.

Also in this case, the two eyelets that were caught rigging keys to the two ends of the binding ropes

after mounting on position of the rudder blade will be cut, and the welding place will be polished.

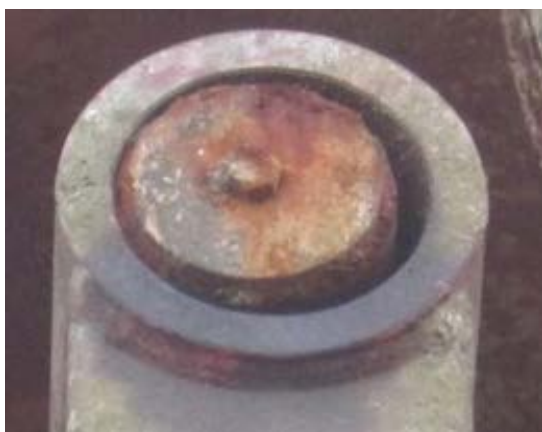
The first reason that motivated the intervention to the steering system was the fact that in the time of the maneuvers when it was necessary the turn of the steering were generated particularly strong vibrations in the hull accompanied by particularly strong noises. These symptoms clearly showed that the bearings of the rudder assembly were worn and worked in dry regime. For this reason, along with breakage of the lubricant film appear the stick-slip phenomenons.

**Fig. 5 The wear of the circular bearing of translation between slide and bushing guider**

Another argument visible with the naked eye without disassembly is in Fig.5. The relative asymmetry between the two cylindrical surfaces of the slide and bushing guide support which should be concentric clearly prove the existence of a very large functional gap.

Obviously this gap occurred due to the wear indicates clearly exceeding the limits of wear.

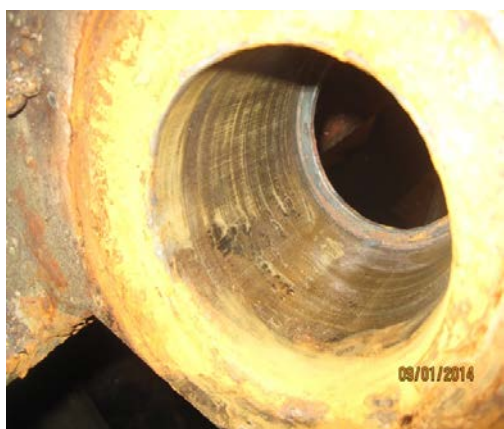
**Fig.6 The bearing hole wear of antifriction alloy from fixing spur of rotated torque of the slide**

From Fig.6, it is visible the depth of planar wear from the bronze support of the rotation pins of the rudder flap and that at dismantling this area of use is free of stable oxides. Establish oxides takes time to stabilize. This lack of stable oxides shows that the wearing phenomenon was continuous and highly aggressive. In the same time, there is an obvious difference between the oxidation state of this flat surface and the inner surface of the bearing. In case of one cylindrical surface, it's presents a darker surface layer, with shades

indicating the presence of chemical compounds of stable reaction, with metallic luster.

One possible explanation would be given that the pressure of contact between the two surfaces and pivot bolt and the amount of the relative displacement between the surfaces with relative movement under the contract is different. It is also clear that the presence of lubricant in the presence of high pressure and relative movement with values and low speeds generates that layer with the characteristics results from the image.

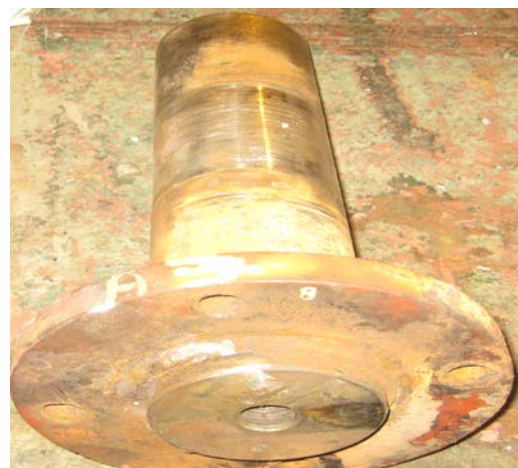
The characteristics contact of the surfaces of the bearing hub can be analyzed by correlation with complementary surfaces of the torque on the shaft (fig.7). As its results from figure, is observed the transfer of oxides and other reaction products resulted after the partially lubricated contact.

We can see spots with different characteristics in terms of couplings color and gloss with slip in the contact area.

**Fig. 7. Anti- wear alloy grip on bolt**

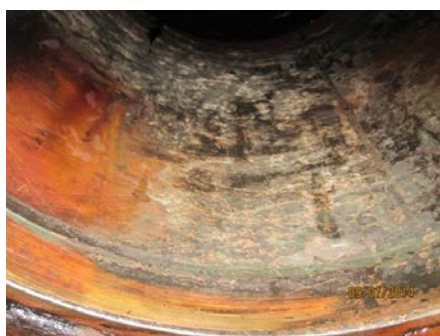
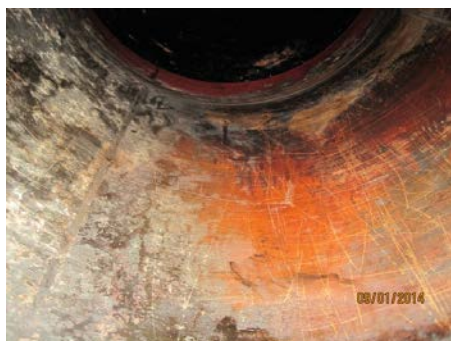
Fig. 8

Referring to fig. 8 we can see the effect of these requests. Although the bearing works with abundant lubrication the anti-friction surface

material presents a spot light arranged on almost the entire height of the bushing bearing. The length of the radial arrangement of this mark it is greater at the bottom and less at the top. This is evidence that during the loading, the bearing shaft is bent which make that the discharge of the radial load on the bearing take variable place on its height. The complete color change of the anti-friction material from bronze to white spotted shows that due to the very high pressure it was carried out it's transformations. Local high pressure caused the exfoliated of the superficial anti-friction material, followed by removal thereof with the lubricating film extrusion.

Destruction in depth of the anti-friction layer is much higher in the lower part of the bearing. This confirms the bending deformation of the main haft of the rudder in embedment.

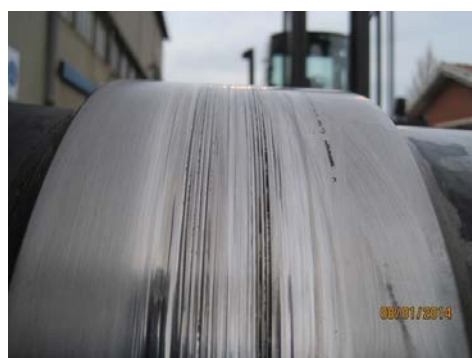
The lack of an additional sealing protective system allowed entering into the working area of the bearing of impurities which were fixed on Teflon bearing, making deeper, uniform, continuous and regular wear channels (fig9). These elements shows the fact that impurities which led to the generation of these wear, were fixed on the bearing realise in time those channels. The connected, rounded shape of the profile of these wear channels, the lack of sharp edges and the specific metallic gloss resulting from splintering shows that impurities were accumulated in time focusing on plastic material acting as an emery in the contact with the anti-friction material of the shaft.

Fig.9 Upper rudder shaft bearing wear
