## Turbocharger breakdown investigation

The objects of research were a four-stroke medium speed marine engines MAK 9M43C type with its ABB turbocharger TPL76-C33 type. The damage to the turbocharger of the 8400kW diesel engine, which operates for about total 66 275 hours, caused losses of over a half million euros.

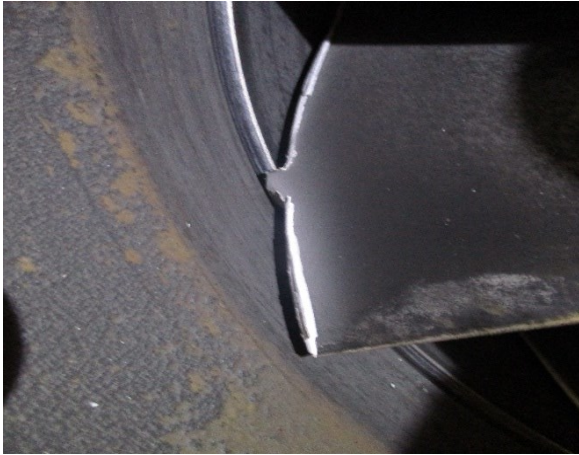
Considering the information available following possible failure causes could have led to the failure of cartridge smooth rotation and the excessive axial movement of compressor wheel supports increase of clearances in radial and axial bearing beyond the limits. This further validates that the bearings and shaft have worn beyond usable limits. The rubbing of the compressor wheel (figure 3) with wall insert may be the consequential damage [9, 10].

**Figure 3.** Compressor Wheel- found severely rubbed.

There are several ways in which the turbocharger may fail and will require replacement. The first mode of failure is due to the degradation of the compressor vanes caused by rubbing of the compressor on the volute (figure 3). In order the turbocharger to be able to operate with stable mode, the internal bearing clearances must be kept within acceptable limits. Also, the compressor bearing clearance continues to wear and increase over time. As the internal compressor end bearing clearance enlarges, the sub synchronous conical whirl amplitude of motion continues to increase, causing the impeller to contact the volute. This causes damage to the compressor vanes and reduces performance. The reduced turbocharger output then requires that the turbocharger be replaced.

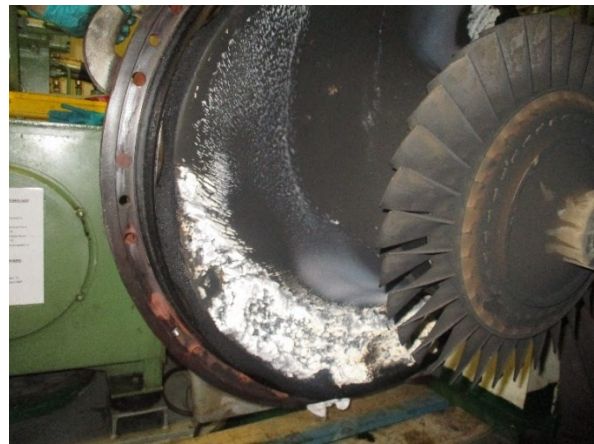
Inspection of these components on board (refer figure 4) relates the fact that there was presence of unburnt oil along with carbon deposits. This could likely be the reason of unbalance in the shaft which might have led to rubbing of compressor wheel and ultimately leading to failure of other components. The source of oil leakage may not be traced back.

**Figure 4.** Hood and Turbine remarks.

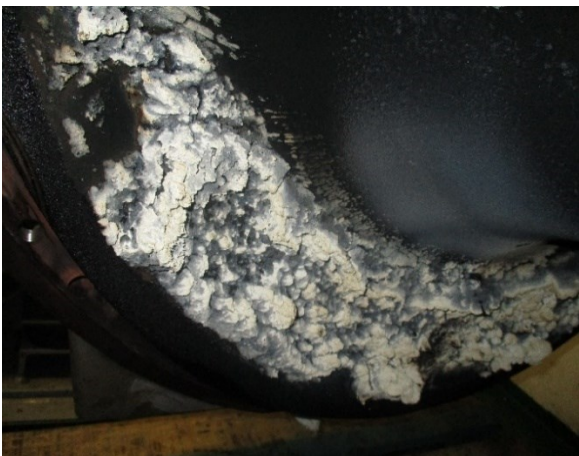
### 2.1. Presence of unburnt oil in nozzle ring, Gas outlet casing and Hood (figure 5 and 6)

Referring the figures of contamination, there is likely the condition of water entry from the Gas outlet casing (figure 5) which has caused contamination by mixing with unburnt oil and carbon leading to unbalance in the shaft and further causing the other components to fail.

**Figure 5.** Contamination with unburnt oil, carbon, water.

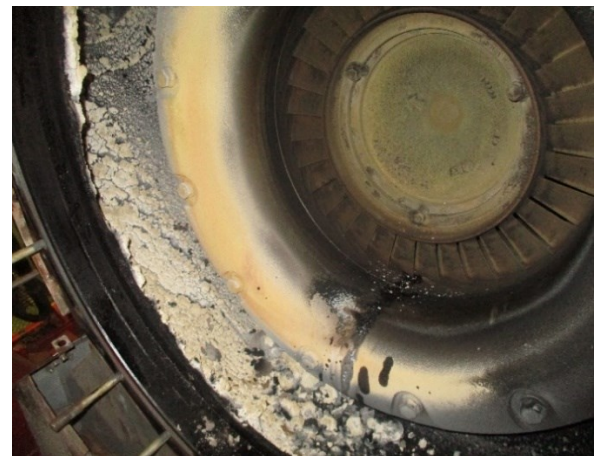
**Figure 6.** Gas outlet casing.
