THE IDENTIFICATION OF THE CAUSES FOR THE FAULTY RUNNING OF NAVAL DIESEL GENERATORS

2. THE DIESEL GENERATORS ONBOARD TRAINING-SHIP MIRCEA

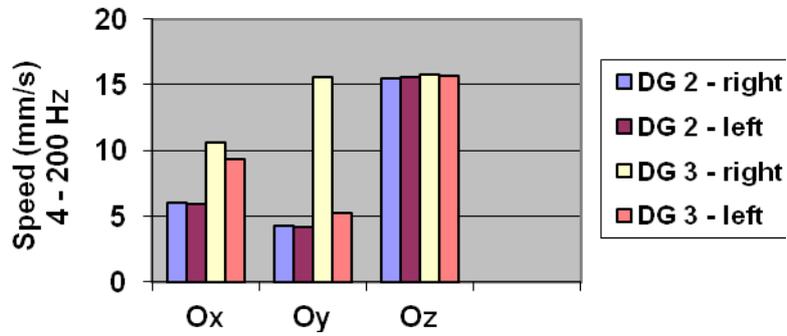
Connection DG 2 + DG 3

Fig.1 Velocity of the vibrations (DG2 connected with DG3)

The analysis showed that the vibrations velocity is below limit in all directions. However, there are noticeable differences between the couplings of the diesel generators. When DG 1 is connected with DG 2, and DG 2 with DG 3, the vibrations reach maximum 15-16 mm/s (transverse direction). In the connections DG 1 + DG 3 and all three generators, the vibrations approach significant the 25 mm/s limit (also, in the transverse direction).

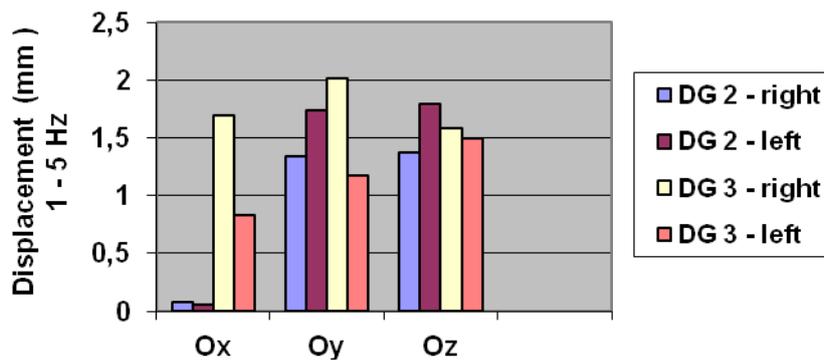
Connection DG 2 + DG 3

Fig. 2 Displacement of the vibrations (DG2 connected with DG3)

The analysis of the vibrations in terms of displacement reveals a similar behavior. But, this time the vibrations are excessive also in the longitudinal direction. In the connection DG 1 and DG 2 the vibrations are below 1mm. In the other connections, the amplitude of the vibrations increase, being in the range 1-2mm for the connection DG 2 + DG 3, but exceeding 2mm for the connections DG 1 + DG 3 and DG 1 + DG 2 + DG 3.

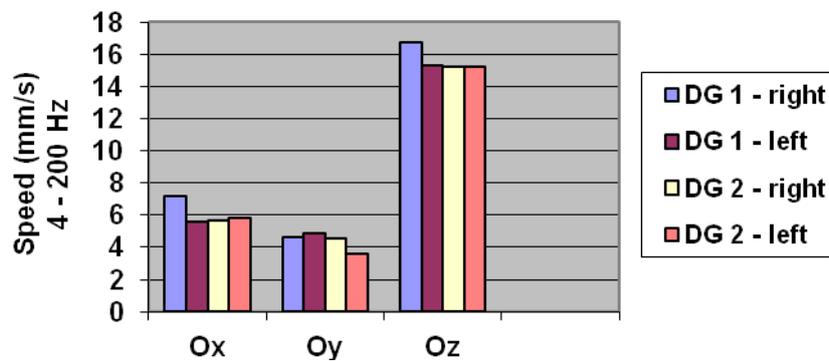
Connection DG 1 + DG 2

Fig. 3 Velocity of the vibrations (DG1 connected with DG2)

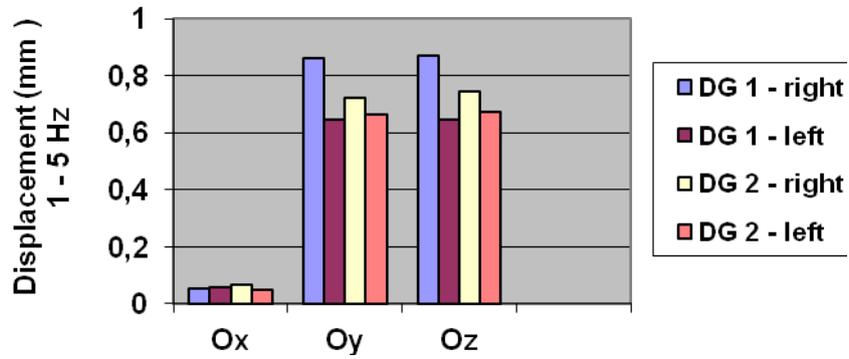
Connection DG 1 + DG 2

Fig. 4 Displacement of the vibrations (DG1 connected with DG2)

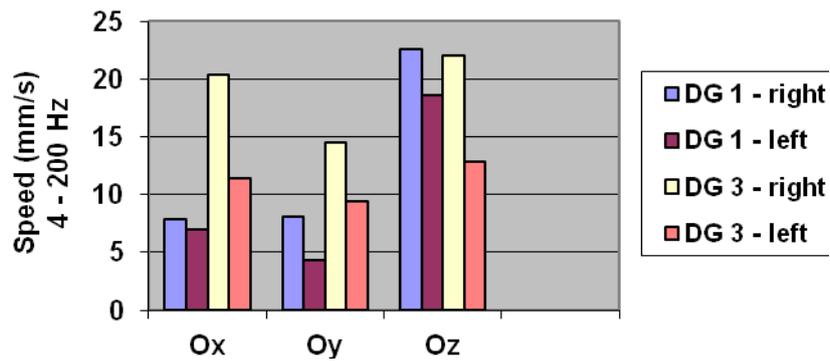
Connection DG 1 + DG 3

Fig. 5 Velocity of the vibrations (DG1 connected with DG3)

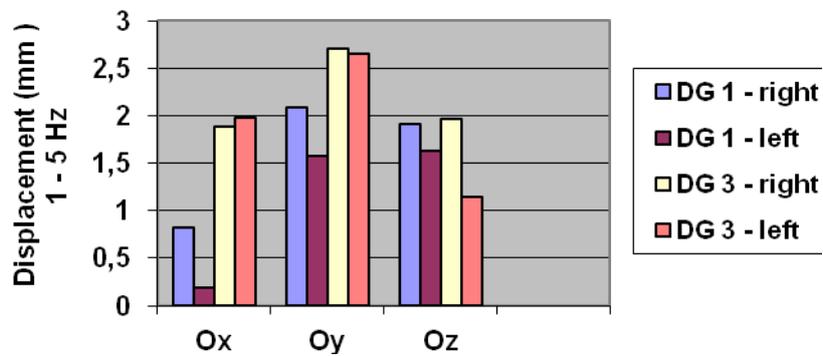
Connection DG 1 + DG 3

Fig. 6 Displacement of the vibrations (DG1 connected with DG3)

But when we analyze the vibrations in terms of displacement, we find that the limit stated in standards is exceeded. Since all three diesel generators are identical and the mountings are also the same, one can expect that the behavior of the DG to be similar. But from all generators, only DG 2 vibrates in the limits. The vibrations of DG 3 and DG 1 exceed the limits, especially DG 3, which vibrations are above 2 mm. The response of the dumpers is similar for the right and left dumper of each diesel generator. But in the connection of all three generators, the left dumper of DG 3 suffers the most excessive vibrations.

The first explanation for this behavior is the coupling system of the diesel generators. Since the generators were designed to run independently, a parallel drive system was installed onboard the ship. This parallel functioning of the diesel generators over the years caused a permanent stress on the generators which led to malfunctions.

A second explanation is the fatigue of the dumpers of the diesel generators. And since the generators can be coupled differently, the physical properties of the dumpers were modified different over the years.

The possible solutions for the problems determined onboard training-ship Mircea are: modifying or replacement of the coupling system of the diesel generators which is the proper solution since the generators will not be replaced; the mounting of new dumpers as a temporary solution.

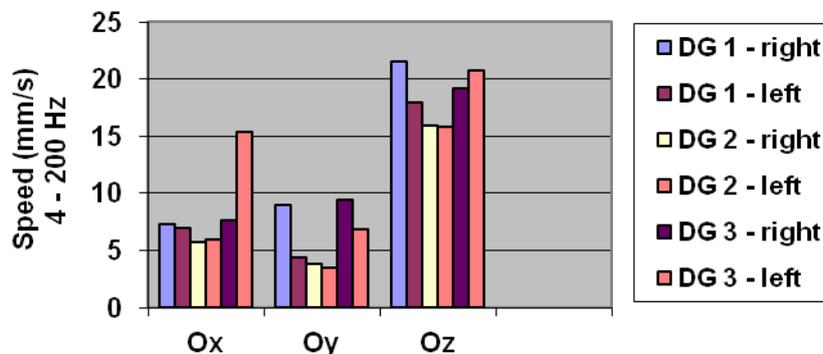
Connection DG 1 + DG 2 + DG 3

Fig. 7 Velocity of the vibrations (DG1 connected with DG 2 and DG3)

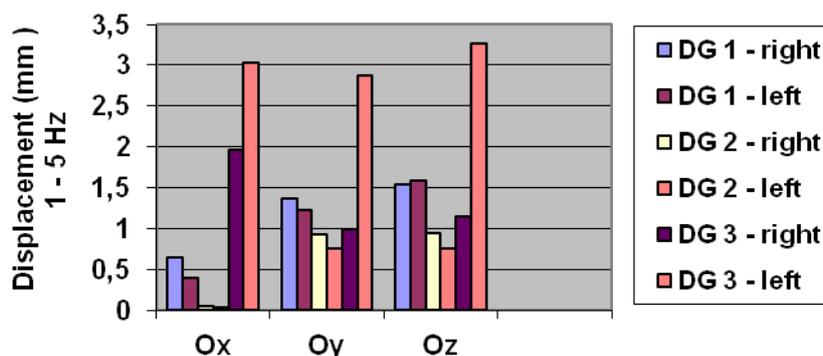
Connection DG 1 + DG 2 + DG 3

Fig. 8 Displacement of the vibrations (DG1 connected with DG 2 and DG3)
