## Turbocharger breakdown investigation

The objects of research were a four-stroke medium speed marine engines MAK 9M43C type with its ABB turbocharger TPL76-C33 type. The damage to the turbocharger of the 8400kW diesel engine, which operates for about total 66 275 hours, caused losses of over a half million euros.

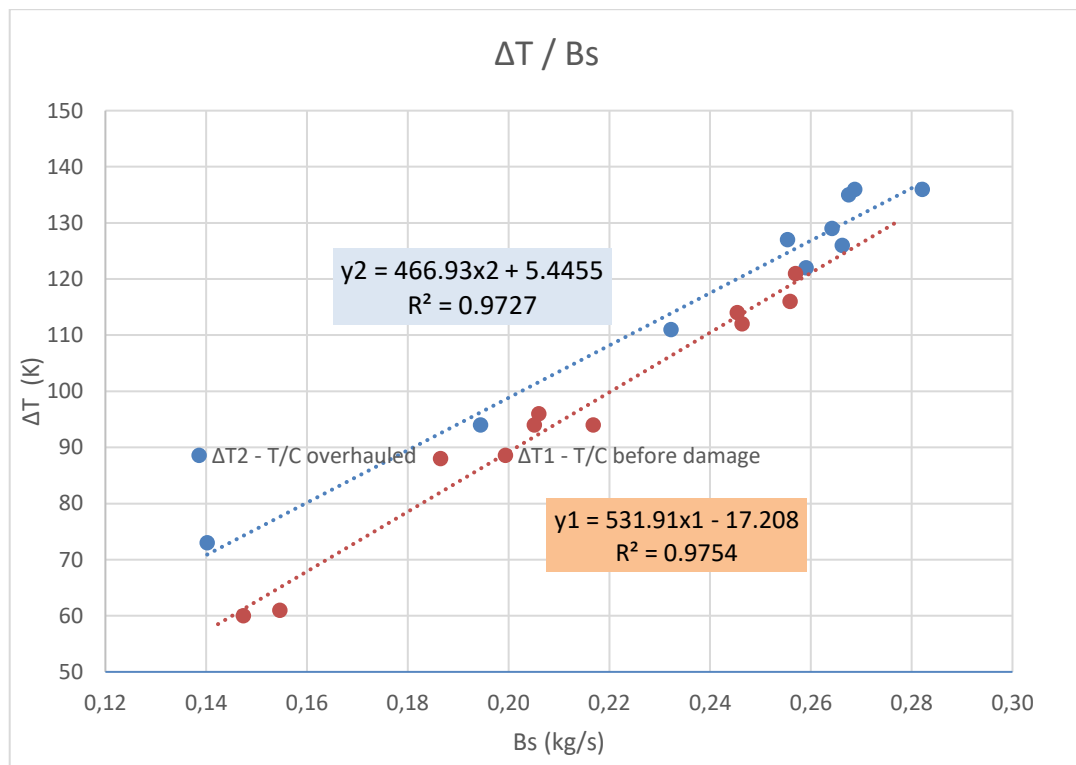
**Figure 3.** Influence turbine temperature drop to fuel consumption.

In figure 3,  $\Delta T_1$  - line represents the temperature drops of turbocharger before the damage of the compressor impeller and  $\Delta T_2$  - line represents the temperature drops of repaired turbocharger (with changed cartridge) as a function of the fuel consumption per second of the main engine Bs (kg/s) [4].

The big difference between linear functions can be seen due to the significant influence of the technical condition of the T/C on the fuel consumption of the main engine.

According to the collected data. when the fuel consumption Bs changes in range 0.1389 – 0.2778 kg/s, which is research interest. The values for  $\Delta T_1$  and  $\Delta T_2$  are given as vector rows in table 4.

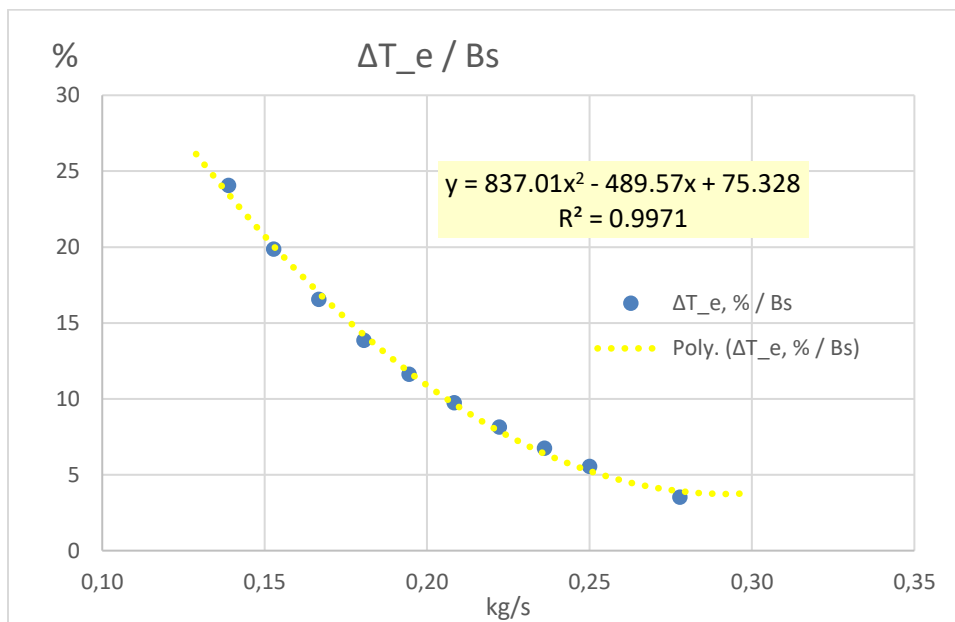
**Figure 4.** Relative error of the turbine temperature drops in percent.

Figure 4 represents the error of the polynomial dependence in percentages of the temperature drop between a turbocharger with a new cartridge and a turbocharger for forthcoming repairs.

The technical condition of the turbocharger has a significant impact on the quality of the combustion process and fuel consumption. As can be seen from figure 4 curve, the influence of the technical condition of turbocharger is significant in small and medium loads, where it reaches 25 % and 10 %, respectively, and in large loads the influence decreases to about 4%.
