THE IDENTIFICATION OF THE CAUSES FOR THE FAULTY RUNNING OF NAVAL DIESEL GENERATORS

2. THE DIESEL GENERATORS ONBOARD TRAINING-SHIP MIRCEA

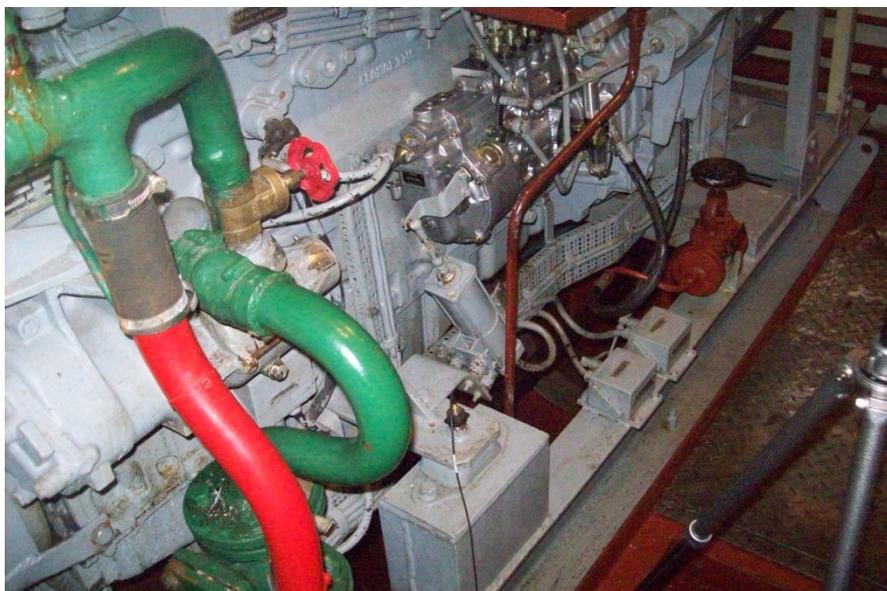
The measurements were made using a triaxial accelerometer DeltaTron type 4506B from Bruel&Kjaer. The accelerometer was placed on coupling between generator block and the resilient mounting, right and left.

The first explanation for this behavior is the coupling system of the diesel generators. Since the generators were designed to run independently, a parallel drive system was installed onboard the ship. This parallel functioning of the diesel generators over the years caused a permanent stress on the generators which led to malfunctions.

The possible solutions for the problems determined onboard training-ship Mircea are: modifying or replacement of the coupling system of the diesel generators which is the proper solution since the generators will not be replaced; the mounting of new dumpers as a temporary solution.
